# SB-U98 & SB-U50 Technical Bulletin

## Firmware Update

Model: SB-U98 & SB-U50, Sony BP-U Series 14.4V Li-ion Batteries

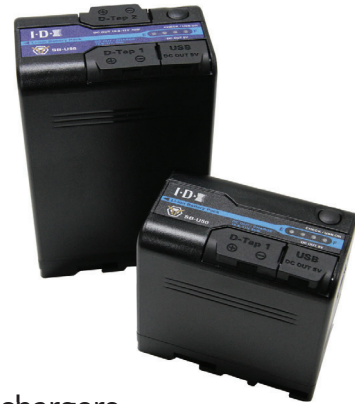
New firmware has addressed two known issues when using these batteries on Sony products.

### Affected Batteries (serial numbers)

SB-U98: BB1CA81H0001 ~ BB1CA81H0500

SB-U50: BA1CA81F0001 ~ BA1CA81F0500

### Symptoms

- \* Will not charge when used with the Sony BC-U2A & BC-U1A chargers.
- \* When used with Sony 4K camcorders, PXW-Z280 & PXW-Z190, the viewfinder will display a 'Low Battery' warning and automatically shut down the camera even with the batteries having sufficient charge.

### Updated Batteries (serial numbers)

SB-U98: BB1ZB91\*\*\*\*\*

SB-U50: BA1ZB91\*\*\*\*\*

*For more information, please contact IDX customer service at (310) 328-2850. All warranty replacements will require a Proof of Purchase, and a Return Authorization Number (RMA). Please visit [www.idxtek.com/rma-request-form/](http://www.idxtek.com/rma-request-form/) to submit a request.*
